**IPU**  
GROUP  
Fuel Conditioning

# CANARY WHARF, LONDON

## THE SOLUTION: DIESEL DEFENCE

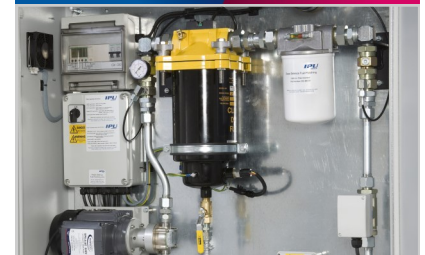
IPU's Diesel Defence maintains fuel quality.

1. In partnership with Optimum Power Services, IPU removed the old fuel polishing system and replaced it with Diesel Defence.
2. Diesel Defence DD90 provides a flow rate of up to 90 litres per minute and maintains fuel to EN590 and ISO 4406 standards.
3. Alongside a fuel polishing unit the team installed vent TRAP filters to prevent dirt and moisture from entering the tank.

IPU Group and Optimum Power Services (OPS) proposed replacing the legacy fuel polishing system with a Diesel Defence DD90. The DD90 will reliably maintain the fuel, be autonomous in operation and could be effective on diesel that included up to 20% biodiesel.

The DD90 offers improved energy efficiency over the legacy system and removes the need to frequently drain hazardous waste from a collection tank, resulting in a considerable annual saving. The Diesel Defence polishing unit also has the capacity to circulate the entire contents of each bulk tank at least 7 times per month, the optimum amount for a complete and thorough circulation.
