When Power is Critical

IPU
GROUP
Fuel Conditioning

GOOD HOPE HOSPITAL

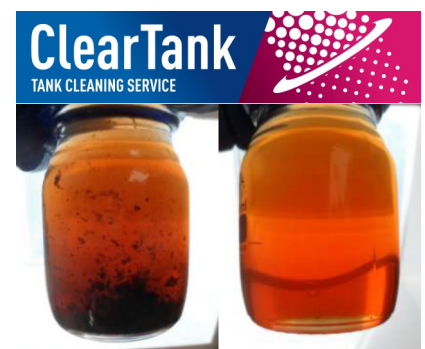
Fuel before (left) and after an IPU ClearTank service (right).

Following an IPU DieselCheck test Good Hope Hospital found that their diesel was heavily contaminated. It contained substances such as colloid carbon (a substance that can clog filters and causes poor combustion). This meant the hospital needed to act quickly as the consequences of a blackout at a hospital would be catastrophic.

Thankfully Good Hope Hospital acted before disaster could strike. IPU's ClearTank service removed the contamination and restored the fuel to quality standards EN590 and ISO 4406. The hospital found IPU's ClearTank service to be entirely unobtrusive as no hazardous man-entry is required, storage tanks are cleaned simultaneously with the fuel and the generators remained online throughout. The hospital has also taken the prudent step to protect themselves by installing IPU's Diesel Defence on each of their tanks. Diesel Defence is a fuel polisher that combines filtration and circulation to keep fuel clean.
